INDOOR AIR QUALITY ASSESSMENT

**Reid Middle School
950 North Street
Pittsfield, MA**

Prepared by:
Massachusetts Department of Public Health
Bureau of Environmental Health
Indoor Air Quality Program
December 2018

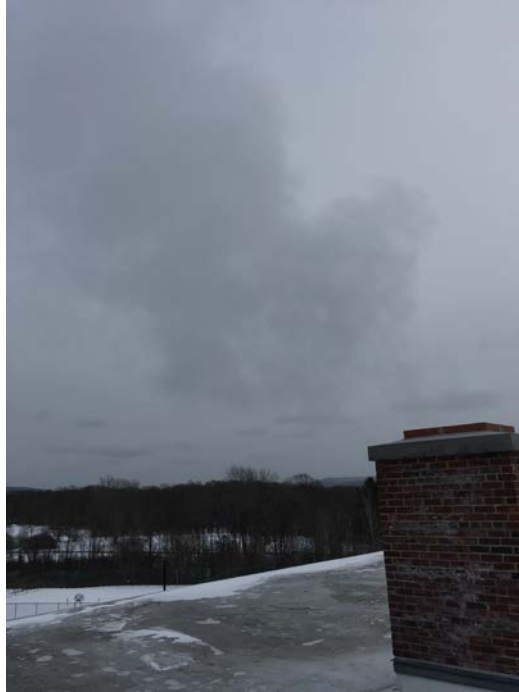
Picture 1

IAQ staff observed the chimney emissions on the roof. A slight westerly wind existed that directed chimney exhaust toward the library wing. At times the plume would move parallel to the ground or upwards (Picture 1). At intermittent times, the exhaust plume appears to dip downwards towards the Room 101 courtyard and the library wing (Picture 2).

Chimney exhaust plume moving in an upward direction

1. Consult with a building engineer to evaluate the function of the boiler exhaust/chimney system and make recommendations to prevent the potential for entraining products of combustion into air intakes and/or directly into occupied areas. Issues that should be considered include:
 - a. The height of the chimney;
 - b. The location of the chimney;
 - c. Chimney materials appropriate for a gas furnace and subfreezing weather; and
 - d. The location of the fresh air intakes for the library wing of the building facing the chimney.

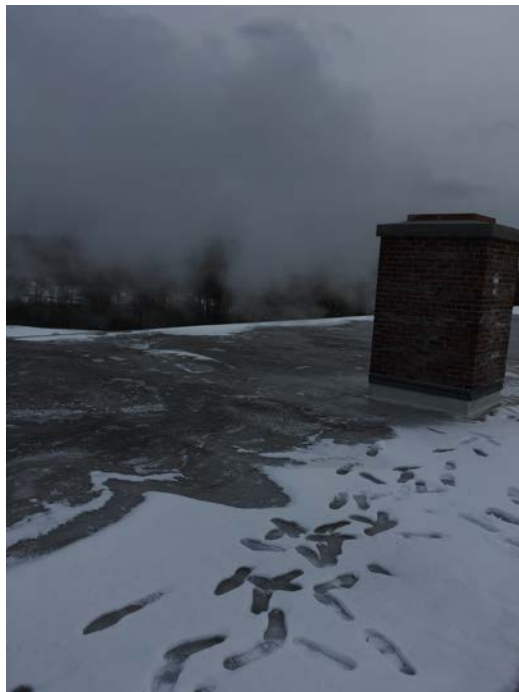
Picture 2

As indicated in the June 2018 IAQ report, it appears that products of combustion from the furnace migrates from the chimney interior into Rooms 101, 103, 205 and 207. This condition appears to be present whenever the furnace is operating. Products of combustion drafting downwards from the chimney towards the Room 101 exterior courtyard does occur intermittently (Picture 1), dependent on weather conditions. Because of this issue, the recommendations made in this report are divided into short-term recommendations and long-term recommendations. The long-term recommendations may require altering the chimney system and/or restructuring

Chimney exhaust plume dipping downwards toward courtyard and library wing
